## WARTIME REPORT

INVESTIGATION OF SURFACE IRREGULARITIES ON AN  
NACA 63(420)-416,  $a = 1.0$  AIRFOIL SECTION FOR  
THE GLENN L. MARTIN COMPANY DESIGN 195

MEMORANDUM REPORT

Army Air Forces, Materiel Command

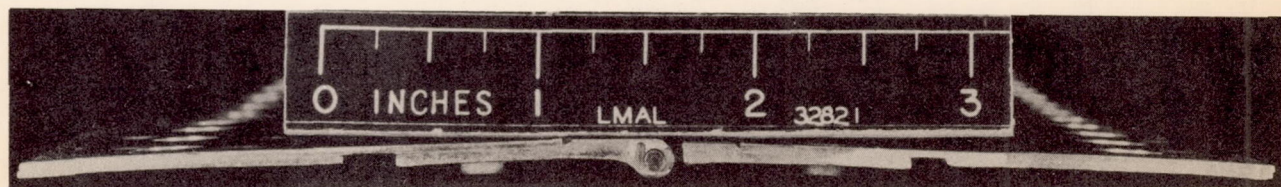
Figure 2.- Piano-hinge skin joint used at front and rear spars of 60-inch-chord, Martin design 195, roughness model, NACA 63(420)-416,  $\alpha = 1.0$  airfoil section.

Photographs of the riveted and piano-hinge skin joints are presented in figures 1 and 2. The riveted skin joint was a butt joint with the skin flush-riveted to an internal metal plate. Some rivets protruded above the skin surface a few thousandths of an inch with very few protruding a maximum height of 0.010 inch; a very small number of rivets were recessed below the skin surface 0.002 to 0.003 inch. The spanwise skin gap was approximately 0.063 inch wide. The piano hinges were butt-jointed to the skin with flush rivets, some of which protruded above the skin surface up to a maximum height of 0.004 inch. The gaps between the hinges and the skin varied in width from about 0.034 to 0.042 inch.
